Manhole Inspection Summary

Manhole # S04EE2020MH

Insp Date: **7/13/06 10:50 AM**

Location Address: **3316 FALLSTAFF RD**

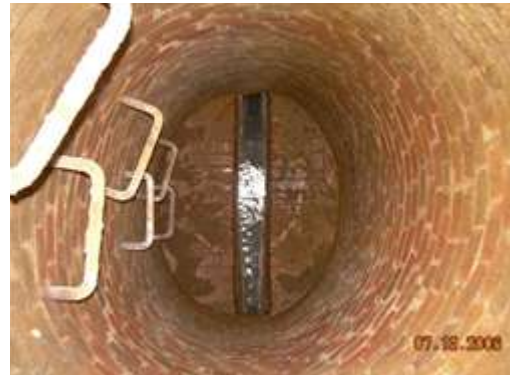
Top View

Bench debris. Adjustment and Barrel infiltration.

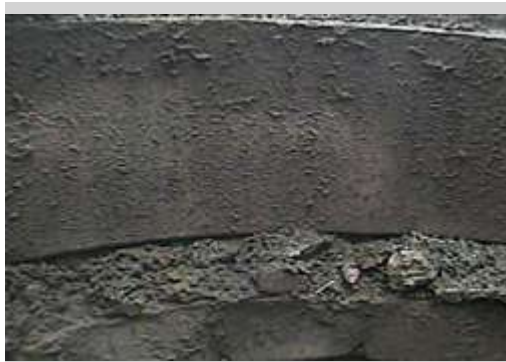
Defect

Frame leaks. Adjustment deterioration and infiltration.

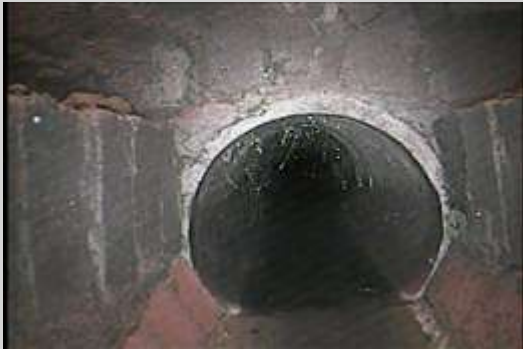
8 in. Circular Gravity Sewer Pipe Out @ 12 O'Clock

Infiltration: **Evidence** Pipe Seal Cond: **Unknown**

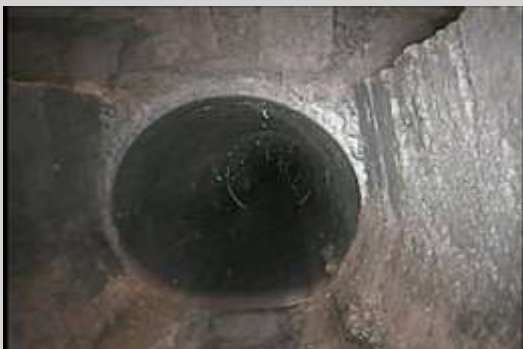
8 in. Circular Gravity Sewer Pipe In @ 6 O'Clock

Infiltration: **Evidence** Pipe Seal Cond: **Unknown**
